RE: Former Jard Facility, Bowen Road, Bennington, Vermont, EPA ID#VTD048141741

MEMORANDUM

SUBJECT: Jard/Roaring Branch Sampling

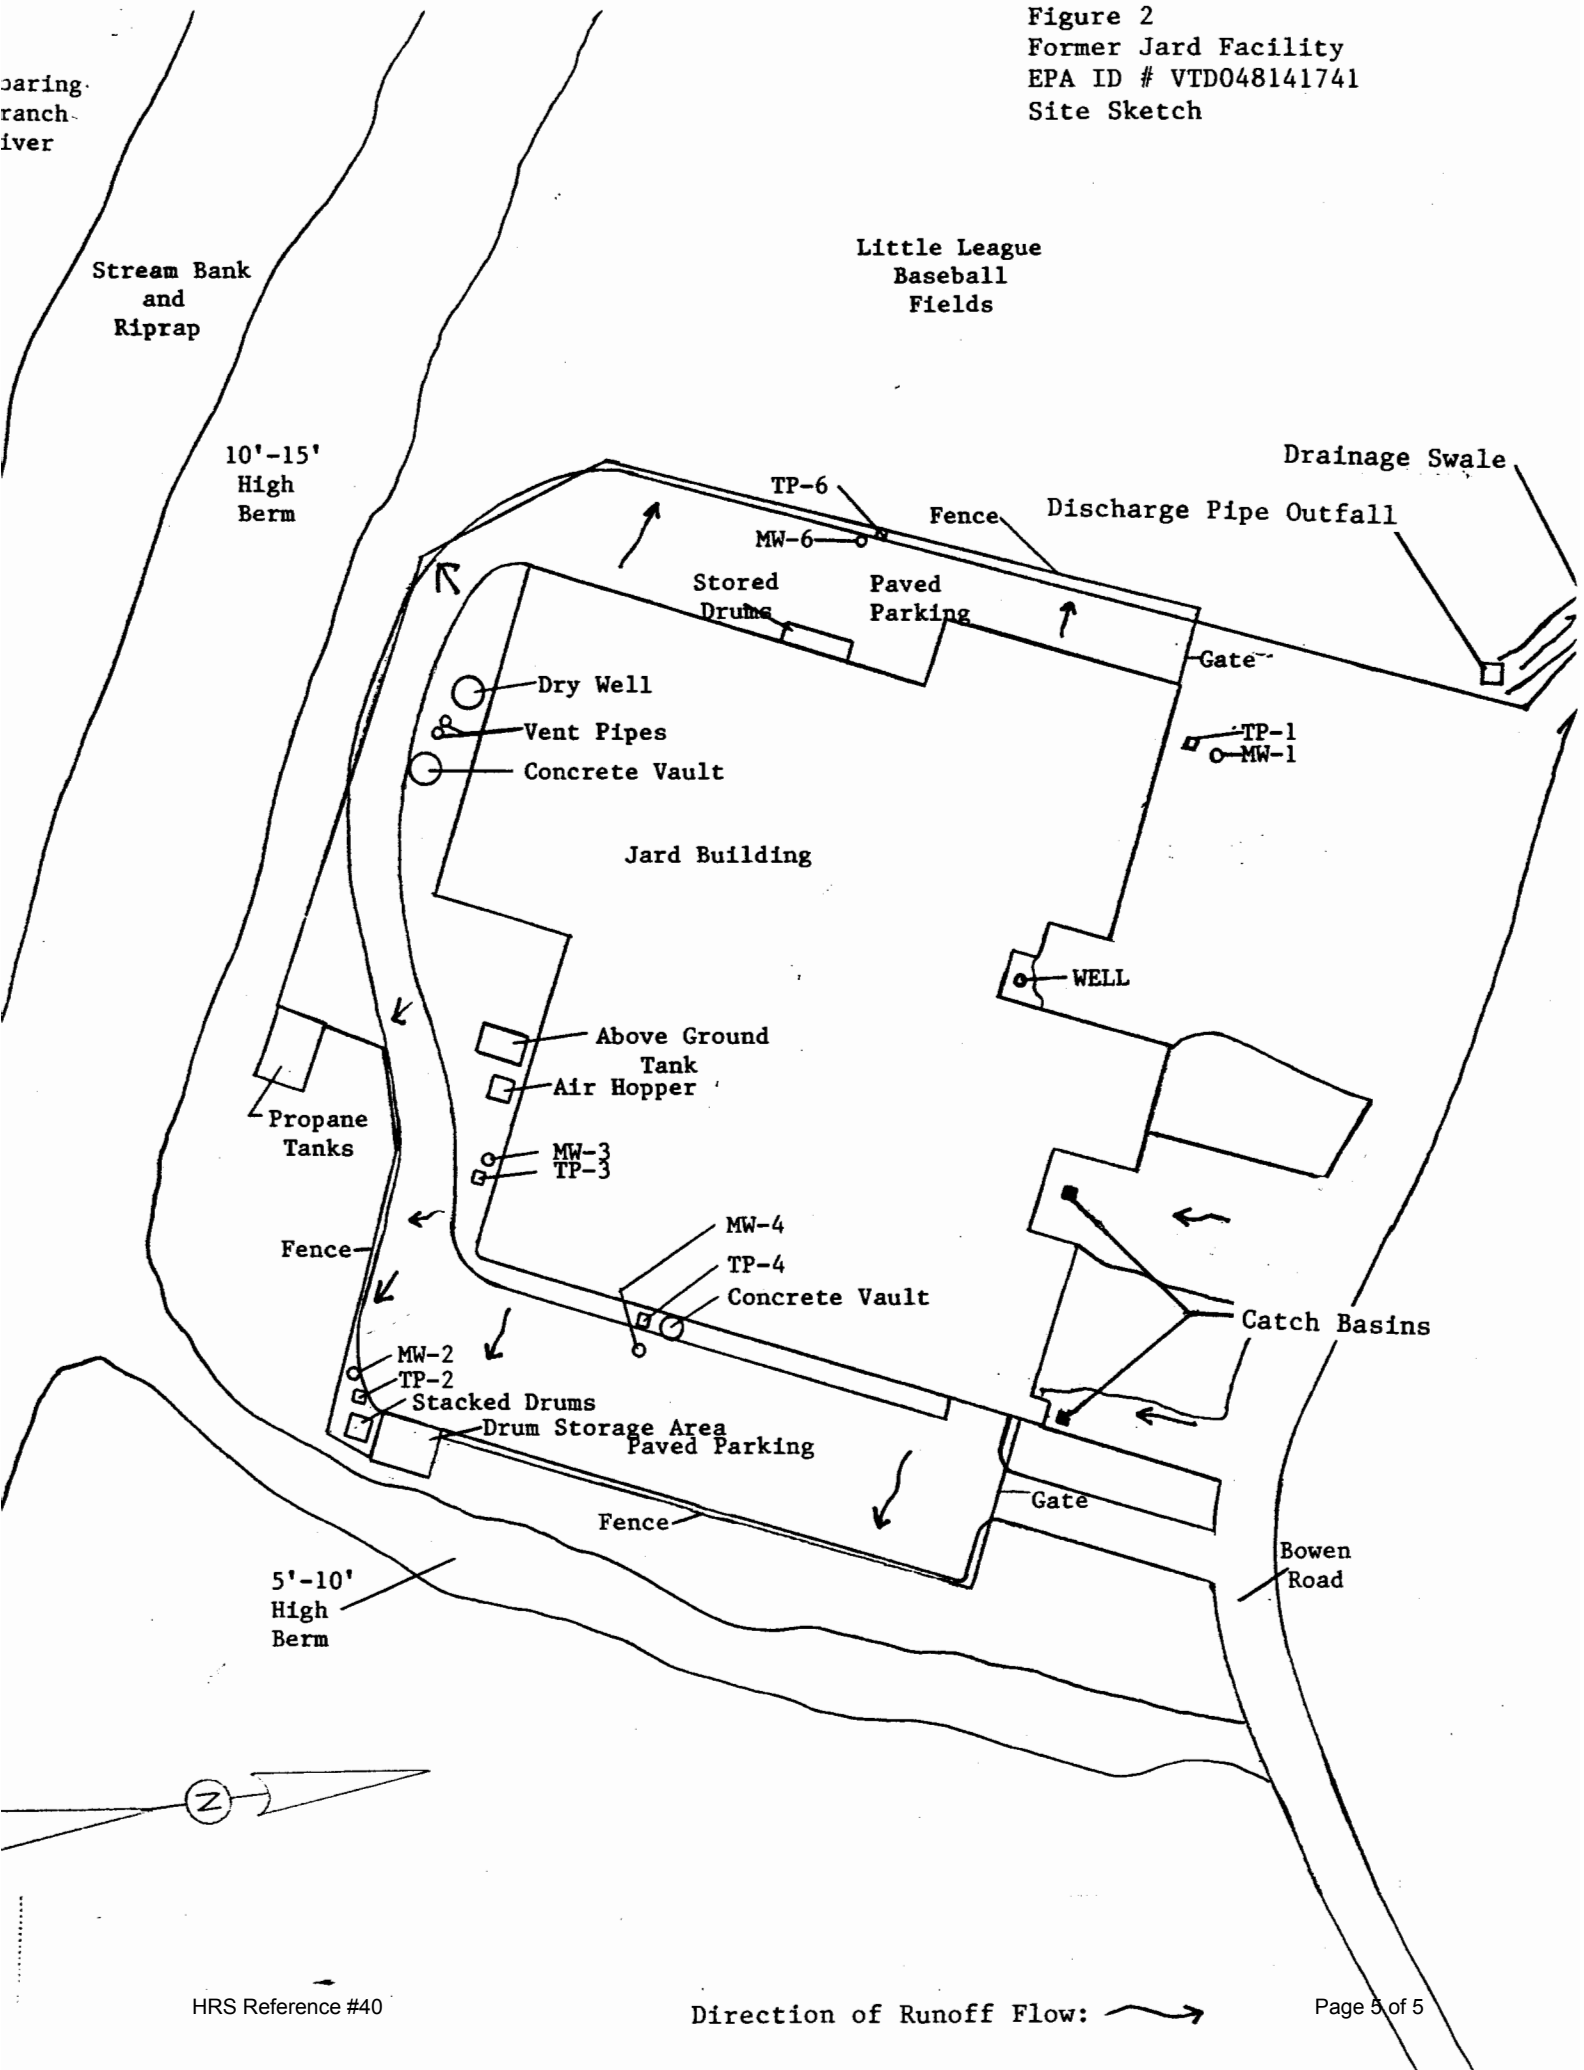
Figure 2
Former Jard Facility
EPA ID # VTD048141741
Site Sketch

We arrived at the former Jard facility at approximately 1054 hours. Weather was clear with a slight breeze. The temperatures was in the low 70's. Temperature rose to the upper 70's during sample collection. A site walk over was conducted to determine over land flow characteristics at the site. A earthen berm/dike is present along the west and south of the facility. The berm rises from approximately three feet near the far eastern entrance to Jard to approximately 15 feet along the southern (rear) of the facility. The berm/dike parallels the Roaring Branch. The berm effectively prevents overland flow from entering the Roaring Branch. A recon of the Roaring Branch did not identify any outfalls discharging flow from the Jard facility to the Roaring Branch. The majority of the area in the immediate vicinity of the facility is paved. It appears that any overland flow at the facility would originate from the paved areas and flow away from the building into the grassy vegetated areas and then infiltrate into the subsurface (See Figure 2).

A drainage swale was identified running along Bowen Road. The swale originates at the northwest corner of the Jard Property. One eight inch and one six inch corrugated steel discharge culverts were located at the head of the swale. The culverts were side by side with the eight inch culvert entering the swale at a 45° angle to the six inch culvert. Both culverts appeared to originate from the Jard facility.

Two storm water catch basins were identified. One was located in a loading dock area along the front central portion of the facility. This basin contained water. The second catch basin was located in the loading dock near the front east corner of the facility. This catch basin did not

contain water. It also had what appeared to be a submersible pump and electrical conduit connected to the basin. It appeared the pump was used to remove excess storm water from the catch basin. The water appeared to have been pumped out of the catch basin and into the building. The discharge point for the water could not be determined.

Sample SD-4 was collected at 1505 hours from the drainage swale originating at the northwest corner of Jard property. Details of the two culverts are discussed on the previous page. Sample material consisted of coarse sand with some gravel.

At the completion of sampling (1530 hours), we walked the drainage swale. The swale paralleled the south side of Bowen Road to the west. Water was not present until approximately 100 yards from the discharge pipes. The water appeared to be natural groundwater discharge as no other outlets/discharge pipes were identified. Water flow increased as we proceeded along the swale. Water passed through a 24"-36" culvert (access to ballfield) and continued in a generally westerly direction. Approximately 25 yards for the intersection of Bowen Road and Park Street, the swale turned to the north. Flow passed through another 24"-36" culvert beneath Bowen Road. Flow eventually discharged to Furnace Brook approximately 200 feet to the north.
